Navajo Abandoned Uranium Mine

Site Screen Report

Mine Name: Radium Hill No. 1 and Utah No. 1

Mine IDs: 258, 259

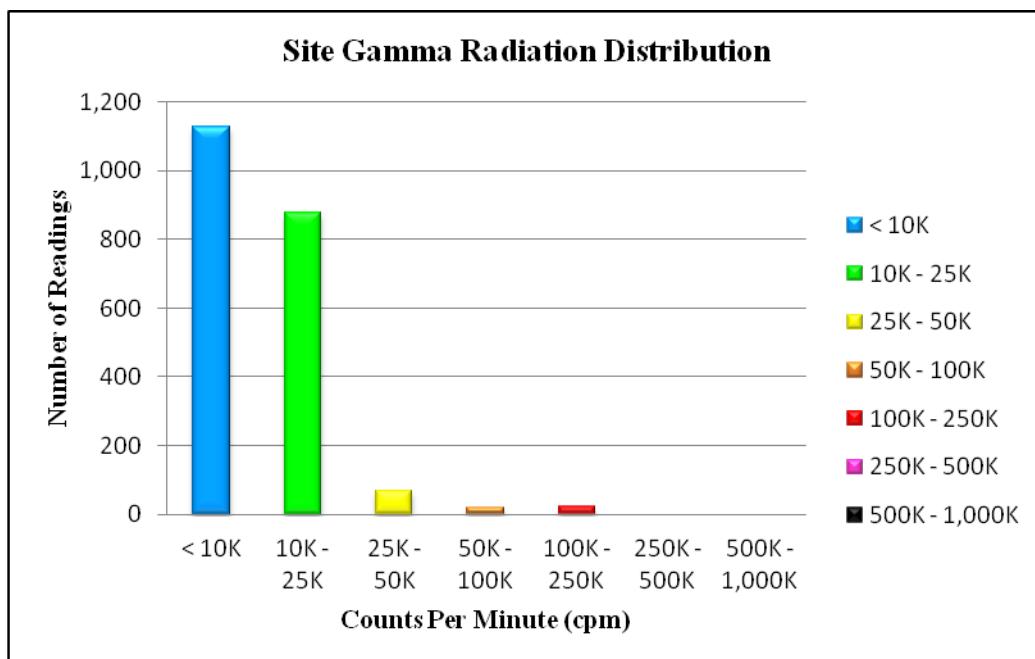
Highest gamma radiation measurement: 147,349 counts per minute (cpm)

Background Average: 9,505 cpm

Two Times Background: 19,010 cpm

A total of 2,115 gamma radiation measurements were collected from the mine site, ranging from 5,351 cpm to 147,349 cpm. Maximum levels of approximately 250,000 cpm were found in reclaimed areas. The measurements are represented in Figures 1 and 2.

Site Gamma Radiation Statistics	
Number of Readings	2,115
Minimum (cpm)	5,351
Maximum (cpm)	147,349
Mean (cpm)	13,295
Median (cpm)	9,758
Standard Deviation	14,173

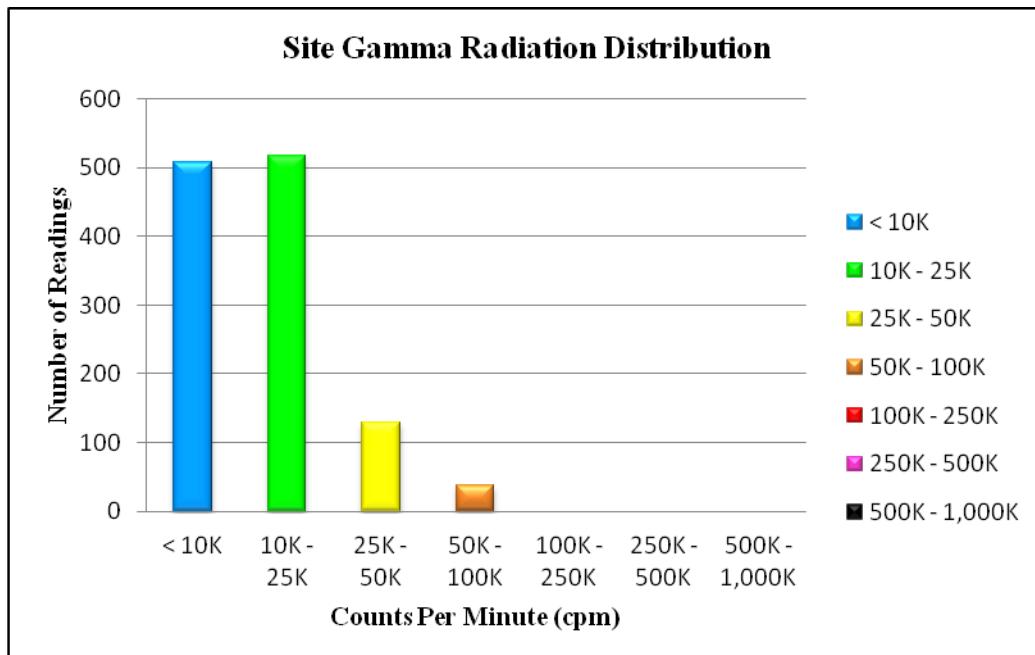
Mine ID: 259**Highest gamma radiation measurement:** 99,273 counts per minute (cpm)**Background Average:** 9,505 cpm**Two Times Background:** 19,010 cpm**Describe any other radiological measurements:**

A total of 1,193 gamma radiation measurements were collected from the mine site, ranging from 5,797 cpm to 99,273 cpm. Maximum levels of approximately 100,000 cpm were found in reclaimed areas. The measurements are represented in Figures 1 and 2.

Site Gamma Radiation Statistics	
Number of Readings	1,193
Minimum (cpm)	5,797
Maximum (cpm)	99,273
Mean (cpm)	16,130
Median (cpm)	10,966
Standard Deviation	13,665
